ECE09402 Project 2D - PCB Assembly & Test

May 1st, 2025

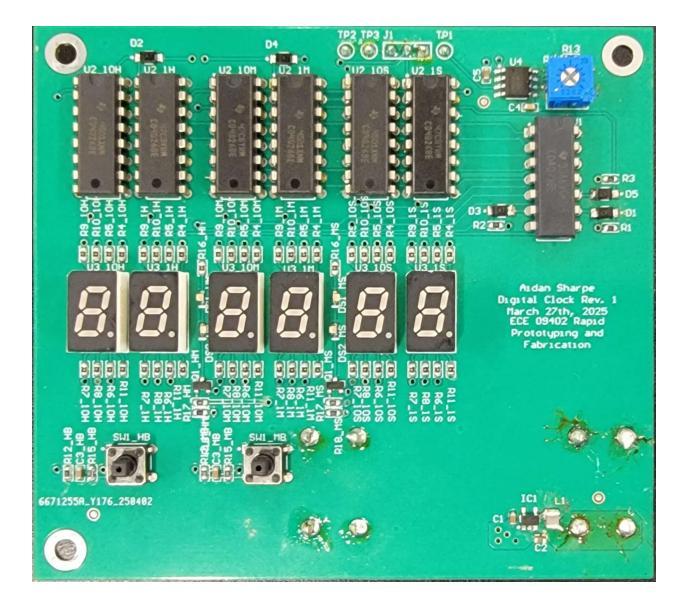
Figure 1: Fully assembled PCB

When the boards arrived, the first step was to solder the surface mount components on. This involved setting up the automatic pick and place machine for pasting and part placement. Unfortunately, when by board was in the pick and place, the paste job failed since the solder paste had become runny. Eventually, we were able to get the paste job working properly running smoothly. With the surface mount parts on the board, we then headed to the reflow oven. After a quick visual inspection, it was time to solder the through hole parts. This soldering step, while tedious, did not have any issues. Once complete, the board was ready for testing.

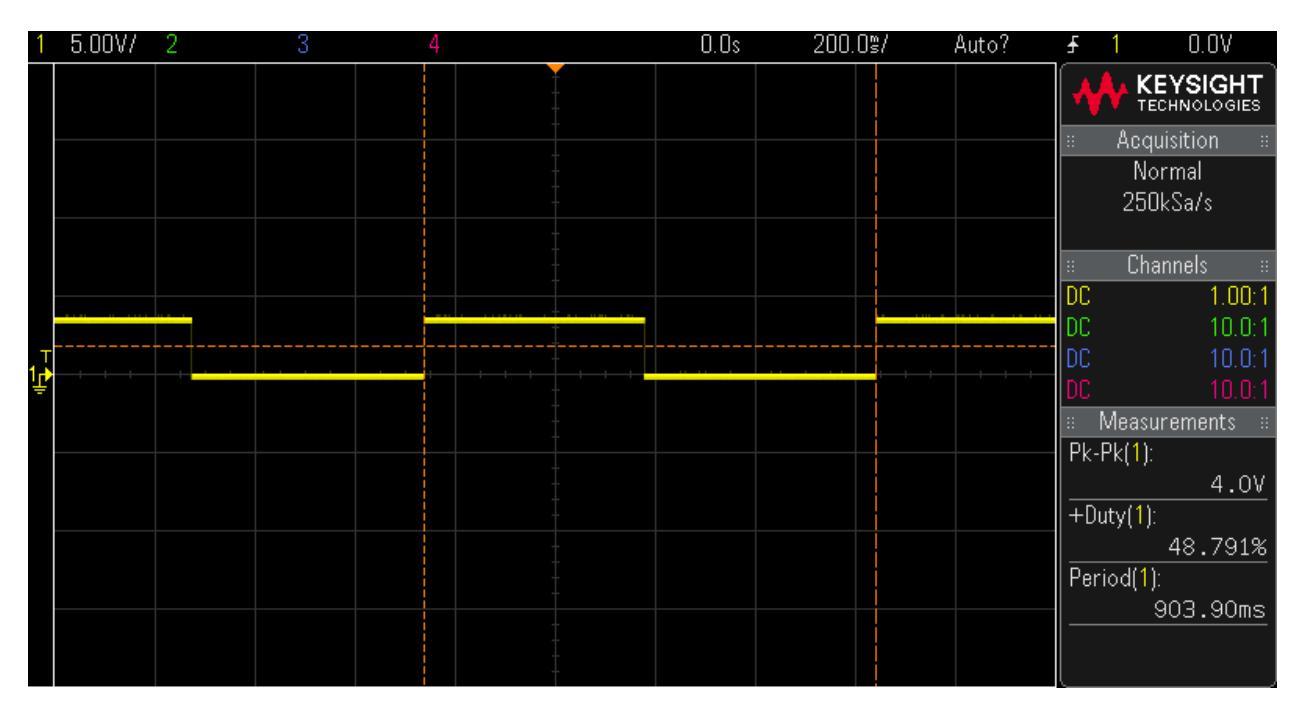
Once we confirmed full functionality, we calibrated the oscillator to get the period as close as possible to one second. Unfortunately, the longest period we could achieve before hitting the limit of the potentiometer was about 900ms as seen in figure 2.

Figure 2: Oscilliscope view of on-board oscillator

Another change I would make would be to the oscillator circuit. Not that a 555 timer will ever be an awesome oscillator, but our choice of potentiometer, in many cases including with my clock, made it impossible to get the clock period to one second. In my case, the best I could do was about 900ms as seen in figure 2. If I were to do this project over (or just pick different parts), I would do some uncertainty analysis to ensure that a period of 1s was well within the range of possible periods given the tolerances of my parts.

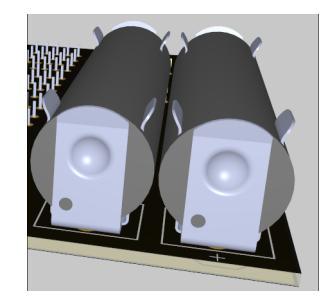
On the topic of dealing with batteries, I also found that my battery connectors were quite close together. This lead to several issues. Since the 3D models in the part library did not show an issue, with the parts intersecting, I figured the placement of the two battery connectors was fine. Only after ordering the board did I notice that, while the battery holder models did not intersect in the 3D view, the tabs would definitely collide with each other when the batteries were inserted. This actually caused several issues, including a short circuit between adjacent connectors that had to be insulated with Kapton tape (Wikipedia contributors 2025). Unfortunately, the connectors had not been de-burred, so the sharp edges made quick work of the Kapton tape, which had to be reinforced with electrical tape.

Figure 3: Battery connector Altium 3D viewer

Additionally, since the battery connectors interfered with each other, it became nearly impossible to pop the batteries out by hand when the board was in the enclosure. Either the case had to be disassembled, or a small pry tool had to be inserted to remove the batteries. This is obviously not ideal and would be another thing I would change in the next revision.

To prevent similar issues in the future, I would recommend modifying the 3D model to show the shape of the battery connectors flexed outward instead of passing through the battery as it is currently.
